**ASBESTOS-CONTAINING MATERIAL
SCREENING SURVEY
CAMPFIRE PROPERTY
8511 15TH AVENUE NORTHEAST
SEATTLE, WASHINGTON**

March 13, 2007
Project No. E-12723-1

Prepared for
Prescott Homes, Inc.
10613 Northeast 38th Place, Suite 17
Kirkland, Washington 98033

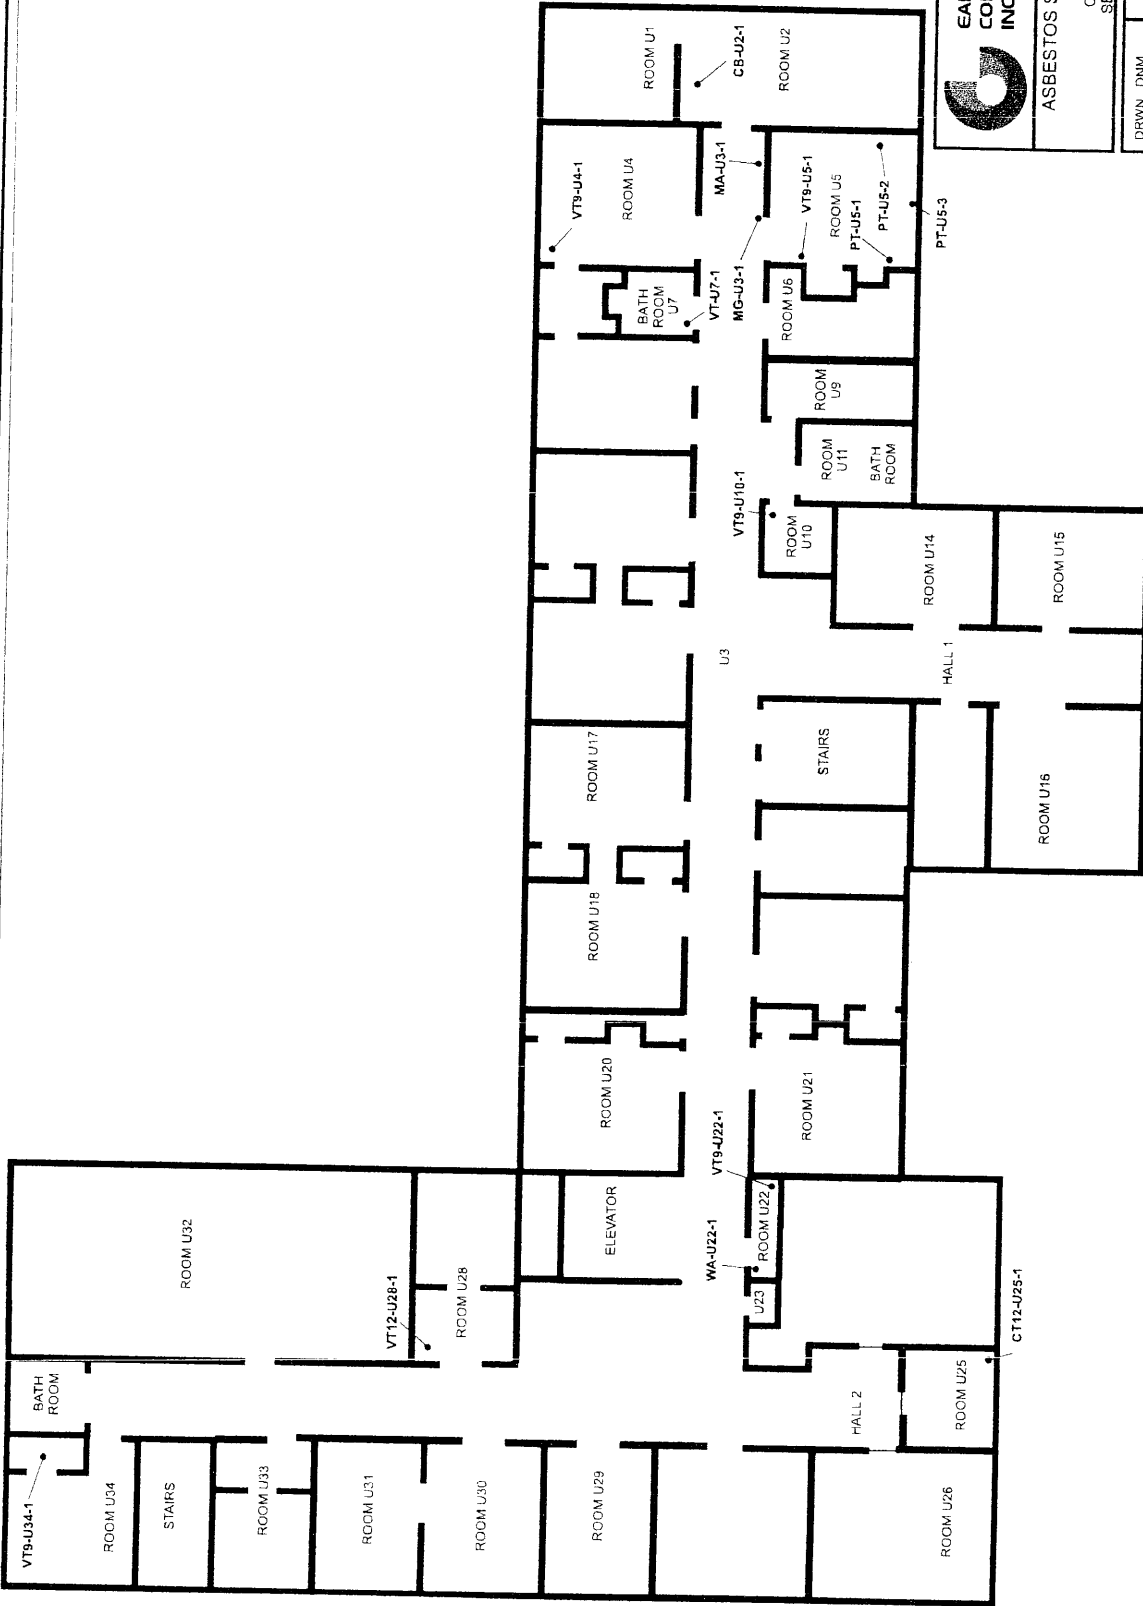
ASBESTOS SURVEY SAMPLE LOCATIONS
UPPER FLOOR
CAMPFIRE PROPERTY
SEATTLE, WASHINGTON

- 9-inch vinyl floor tile in Room U4
- 9-inch vinyl floor tile and mastic in Room U10
- 9-inch vinyl floor tile in Room U22
- 12-inch vinyl floor tile in Room U28
- 9-inch vinyl floor tile in Room U34
- Roofing material at Outbuilding 1
- Vibration damper woven material in Elevator shaft
- Pipe lagging in Elevator shaft

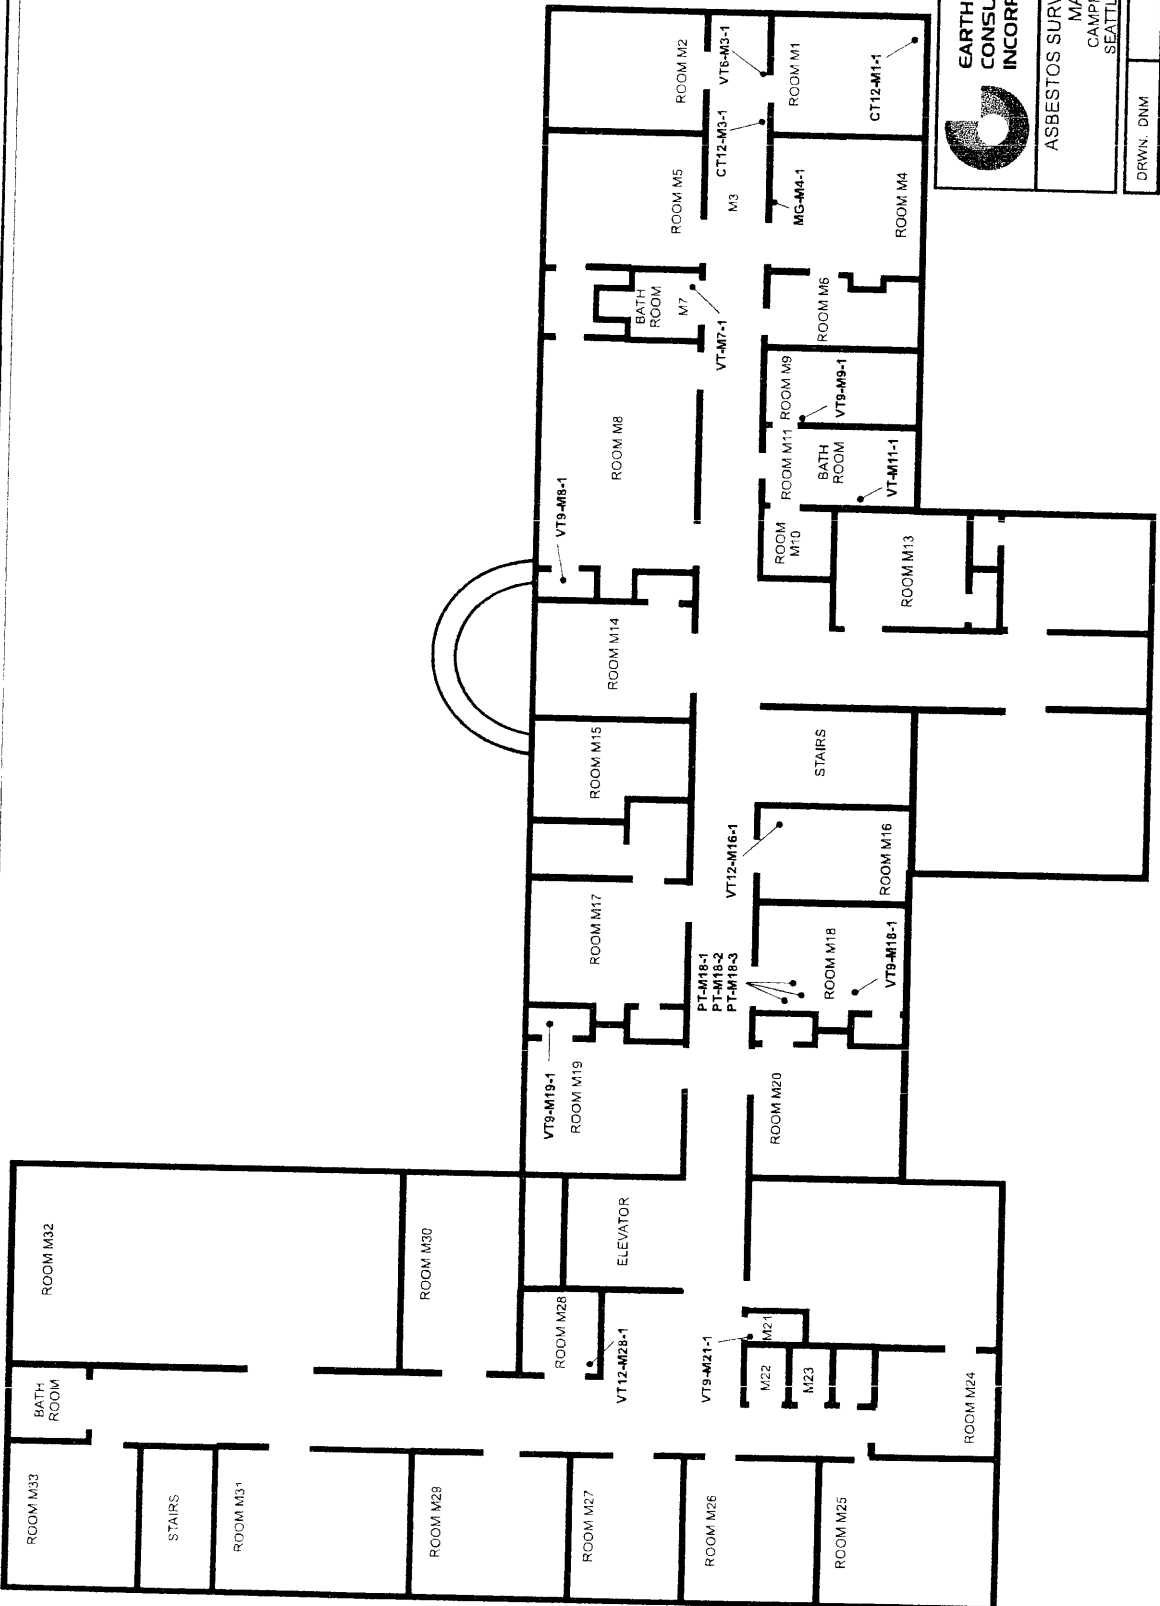
ASBESTOS SURVEY SAMPLE LOCATIONS
MAIN FLOOR
CAMPFIRE PROPERTY
SEATTLE, WASHINGTON

- 9-inch vinyl floor tile and mastic in Room M18
- 9-inch vinyl floor tile and mastic in Room M19
- 9-inch vinyl floor tile in Room M21

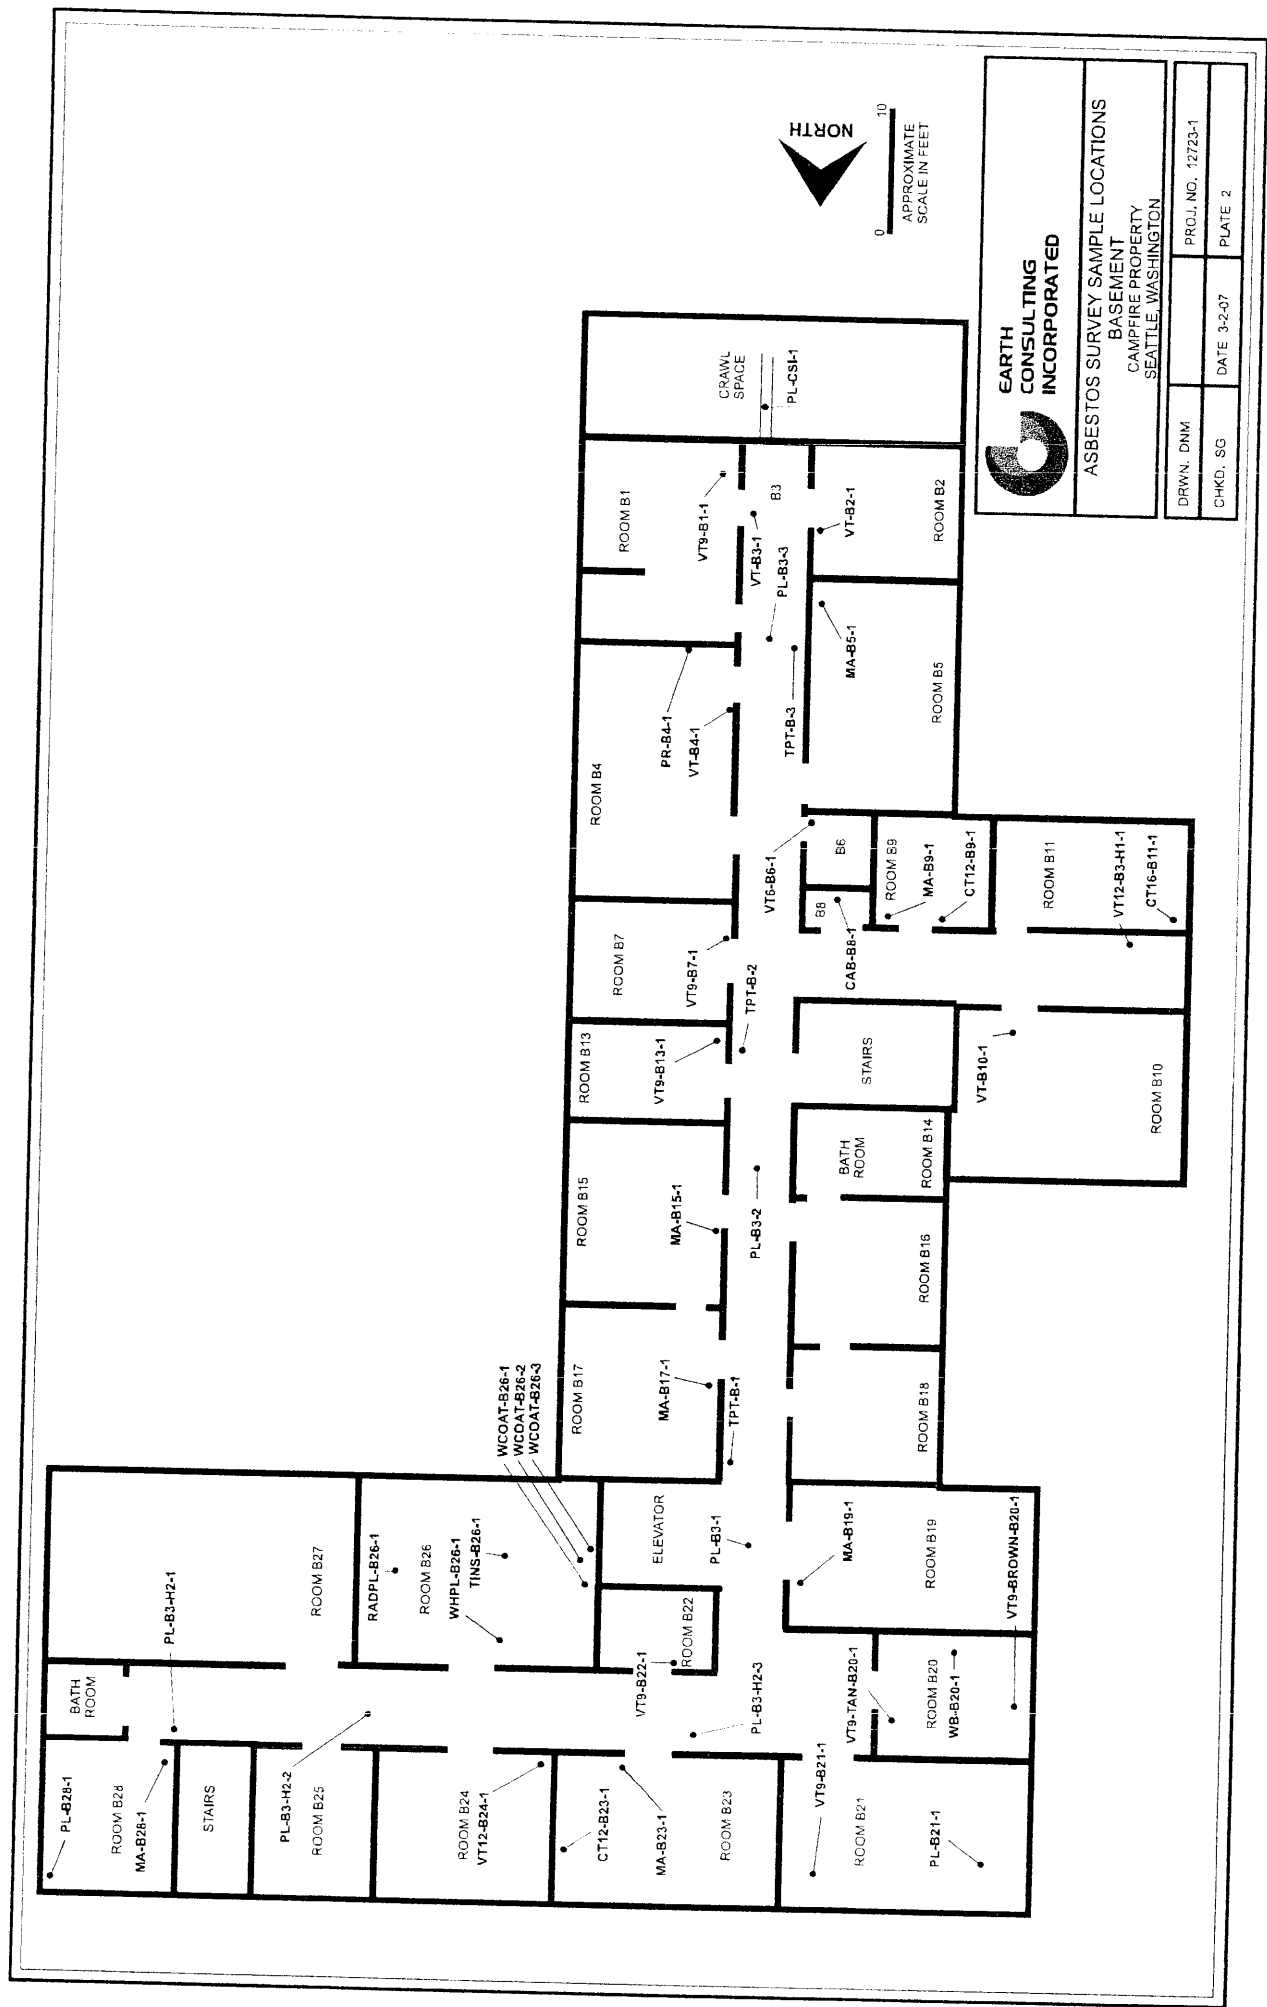
ASBESTOS SURVEY SAMPLE LOCATIONS
BASEMENT
CAMPIRE PROPERTY
SEATTLE, WASHINGTON

- Pipe lagging in the crawl space area
- 9-inch vinyl floor tile and mastic in Room B1
- Vinyl floor tile in Rooms B2 and B3
- Vinyl floor tile and mastic in Room 4
- Carpet mastic in Room B5
- 9-inch vinyl floor tile in Room B7
- Cement asbestos board in Room B8
- 12-inch vinyl floor tile in Hallway B3
- 9-inch vinyl floor tile in Room B13
- Carpet mastic in Rooms B15 and B17
- 9-inch tan and brown vinyl floor tile in Room B20
- 9-inch vinyl floor tile in Room B21
- Pipe lagging in Room B21
- 9-inch vinyl floor tile in Room B22
- Vinyl floor tile and mastic in Room B23
- Water heater and radiator pipe lagging in Room B26
- Tank Insulation in Room B26
- Carpet mastic in Room B28
- Pipe lagging in main hallway B3
